THIRD FIVE-YEAR REVIEW REPORT

BAILEY WASTE DISPOSAL SUPERFUND SITE

ORANGE COUNTY, TEXAS

September 2010

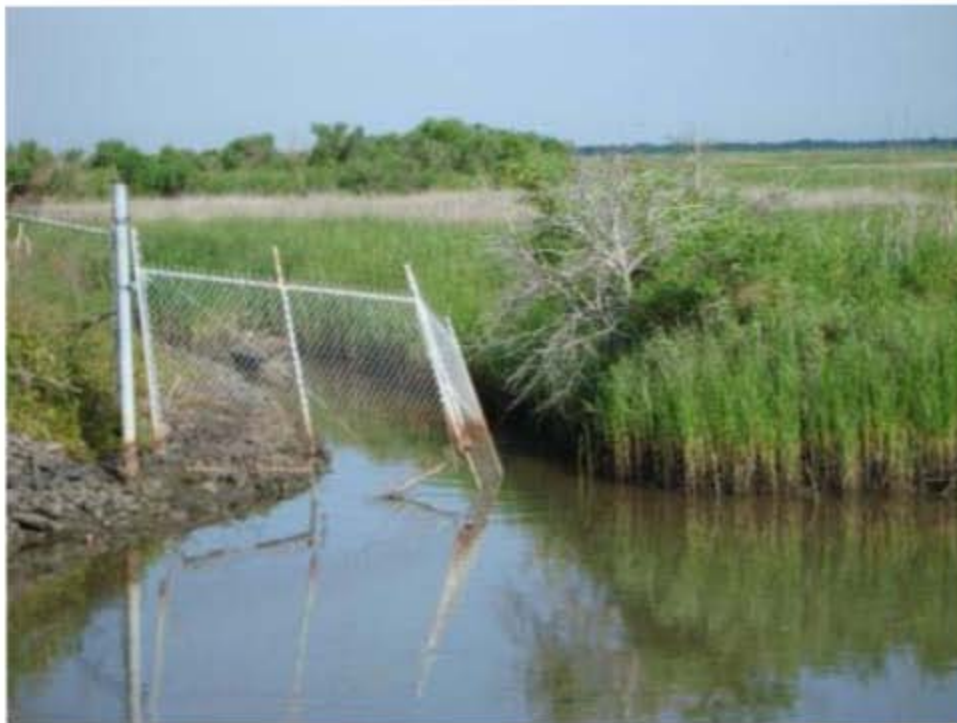
- **Site Access Issues**—Fencing located to the north of the main entrance gate has been corroded and the integrity has been compromised.
- **Insect Mounds and Cap Depressions**—Fire ant mounds and a small depression were noted between the “W1” and “W2” vents along the North Dike.

Photograph No. 3
Description: Fencing north of main entrance gate.
Date: 18 May 2010

- Consider watering the North Dike and East Dike Caps in times of drought or low rainfall to minimize soil cracking.
- Repair the fencing to the north of the main entrance gate.

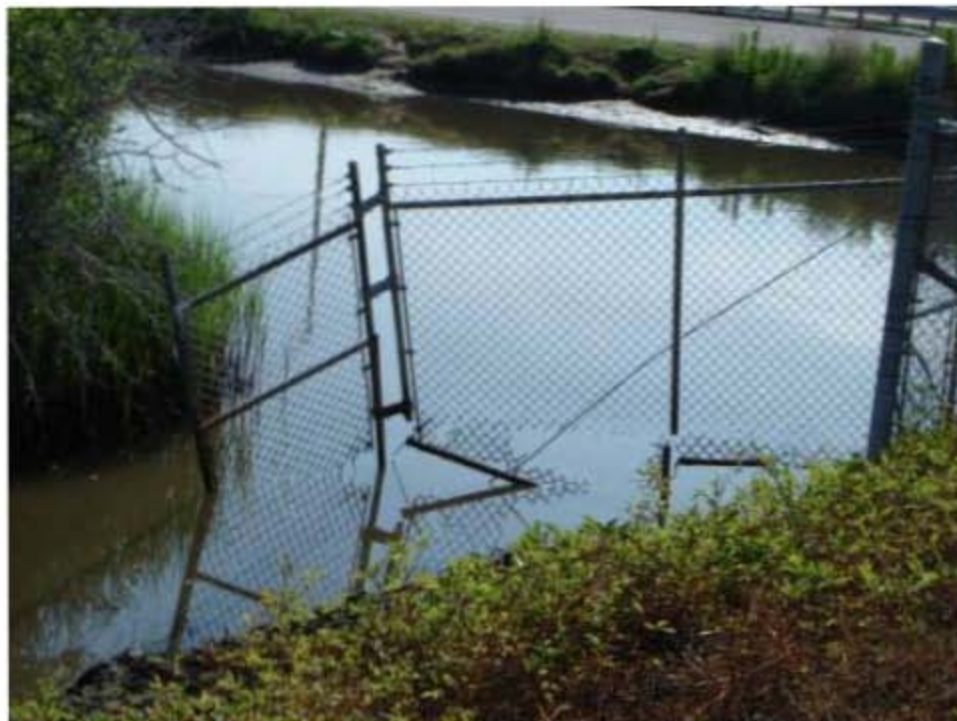
Photograph No. 4
Description: Alternate view of fence north of main entrance gate.
Date: 18 May 2010

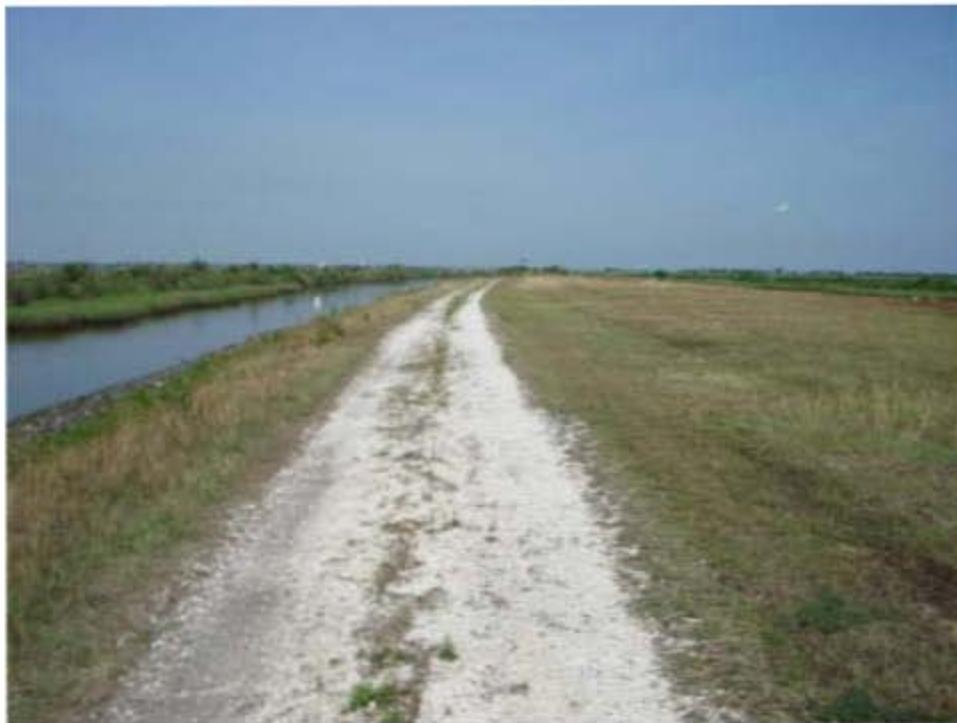
Photograph No. 17
Description: North Dike Cap access road.
Date: 18 May 2010

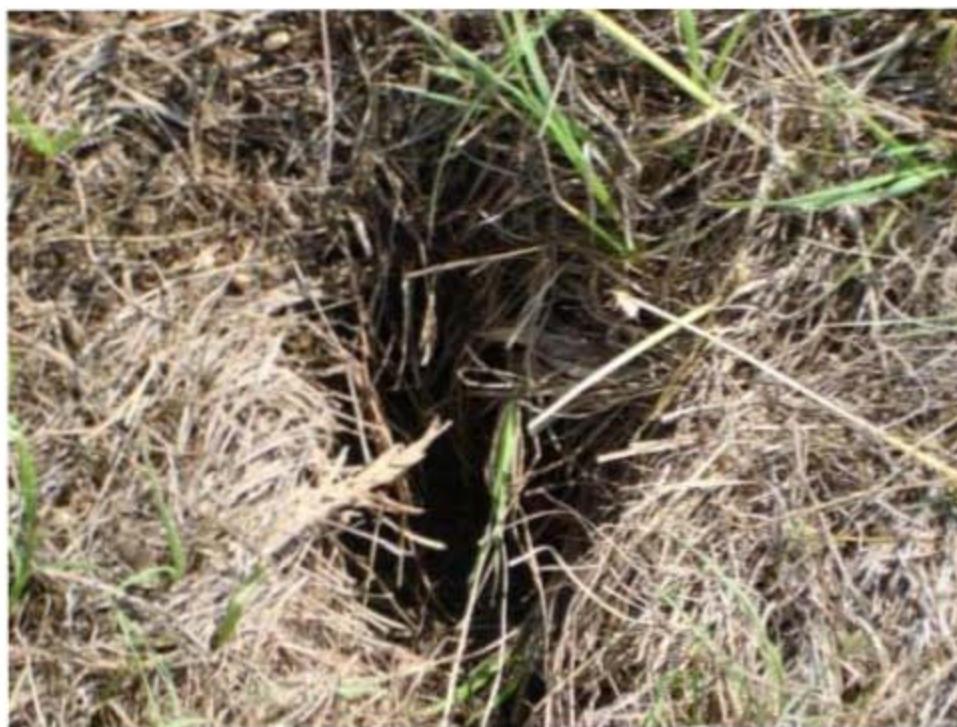
- **Animal Activity**—An abandoned armadillo burrow was noted along the North Dike Cap between the second and third “W” vents. It should be noted that based on the finding of the five-year review inspection, no new animal burrows appear to have been created since Hurricane Ike in 2008.

Photograph No. 18
Description: Old abandoned burrow found in grass on North Dike Cap.
Date: 18 May 2010

- Perform bridge maintenance to reduce corrosion. In addition to regular maintenance prescribed in the Final IMMP (Parsons and GeoSyntec 1997), it is recommended that corroded areas be sanded and painted.
- Repair the burrowed cap areas and backfill burrows with a competent backfill material.
